# The POWER of position

by Robert Kaplan

Predictive Maintenance Engineer  
Florida Power & Light  
St. Lucie Plant

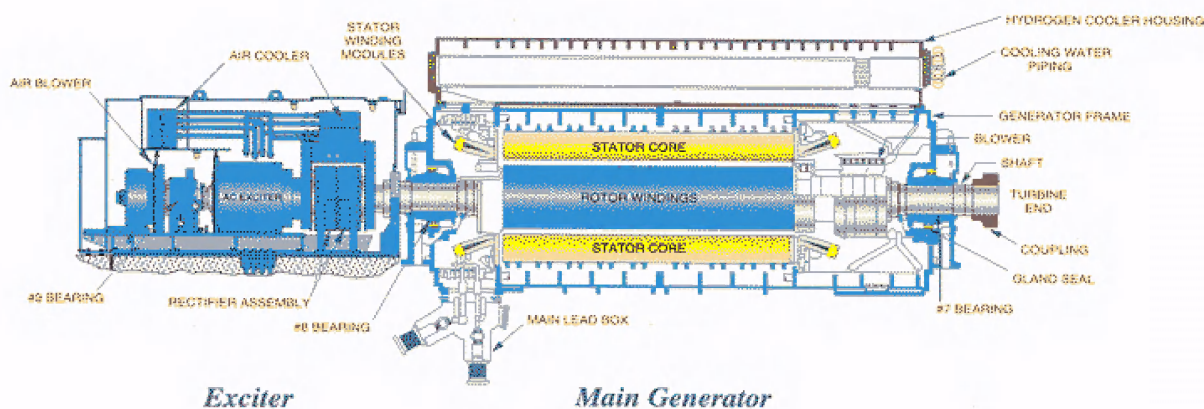
Figure 1

Bearings #7 and #8 support the generator rotor, and Bearings #8 and #9 support the exciter rotor. Bearing #9 also supports an overhung fan and permanent magnet generator (Figure 1). None of these bearings has an oil lift system.

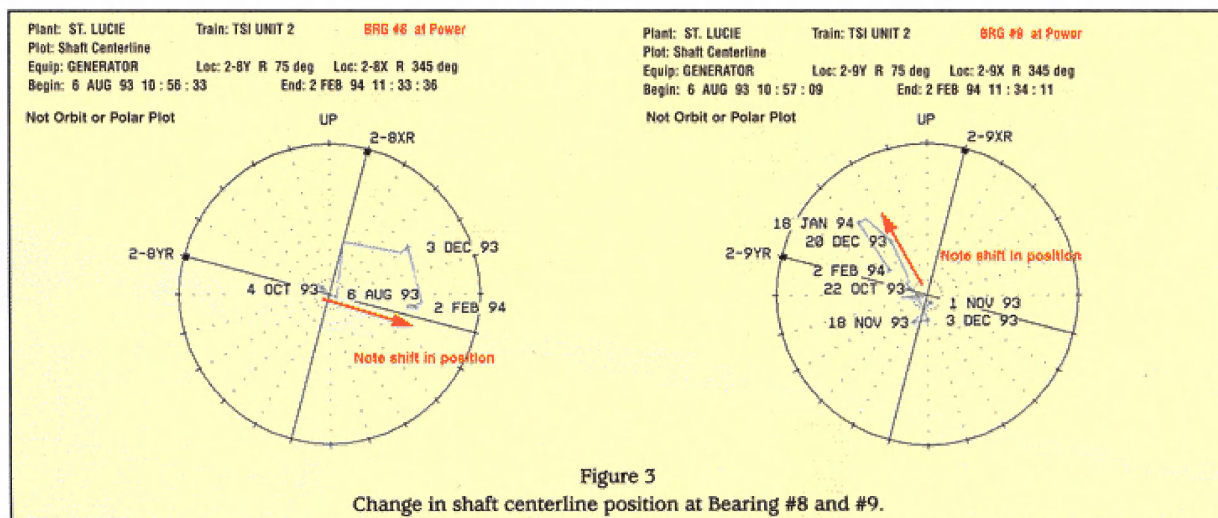
- 1) Bearing #7: The 1X relative vibration patterns did not significantly change.
- 2) Bearing #8: The 1X relative vibration levels increased 1.9 mils to 2.6 mil pp and stabilized at this increased level. The 1X phase angles didn't significantly change. *More significantly, the shaft position had immediately shifted 6 mils horizontally.*
- 3) Bearing #9: The 1X relative vibration levels increased by 1.2 mil pp over the next 15 weeks to 3.4 mil pp.

The 1X phase angle of the Y and X vibration signals increased 31 degrees and 108 degrees, respectively. *The shaft position also shifted 6 mils, but in the opposite direction from Bearing #8, over the next several weeks (Figure 3).*

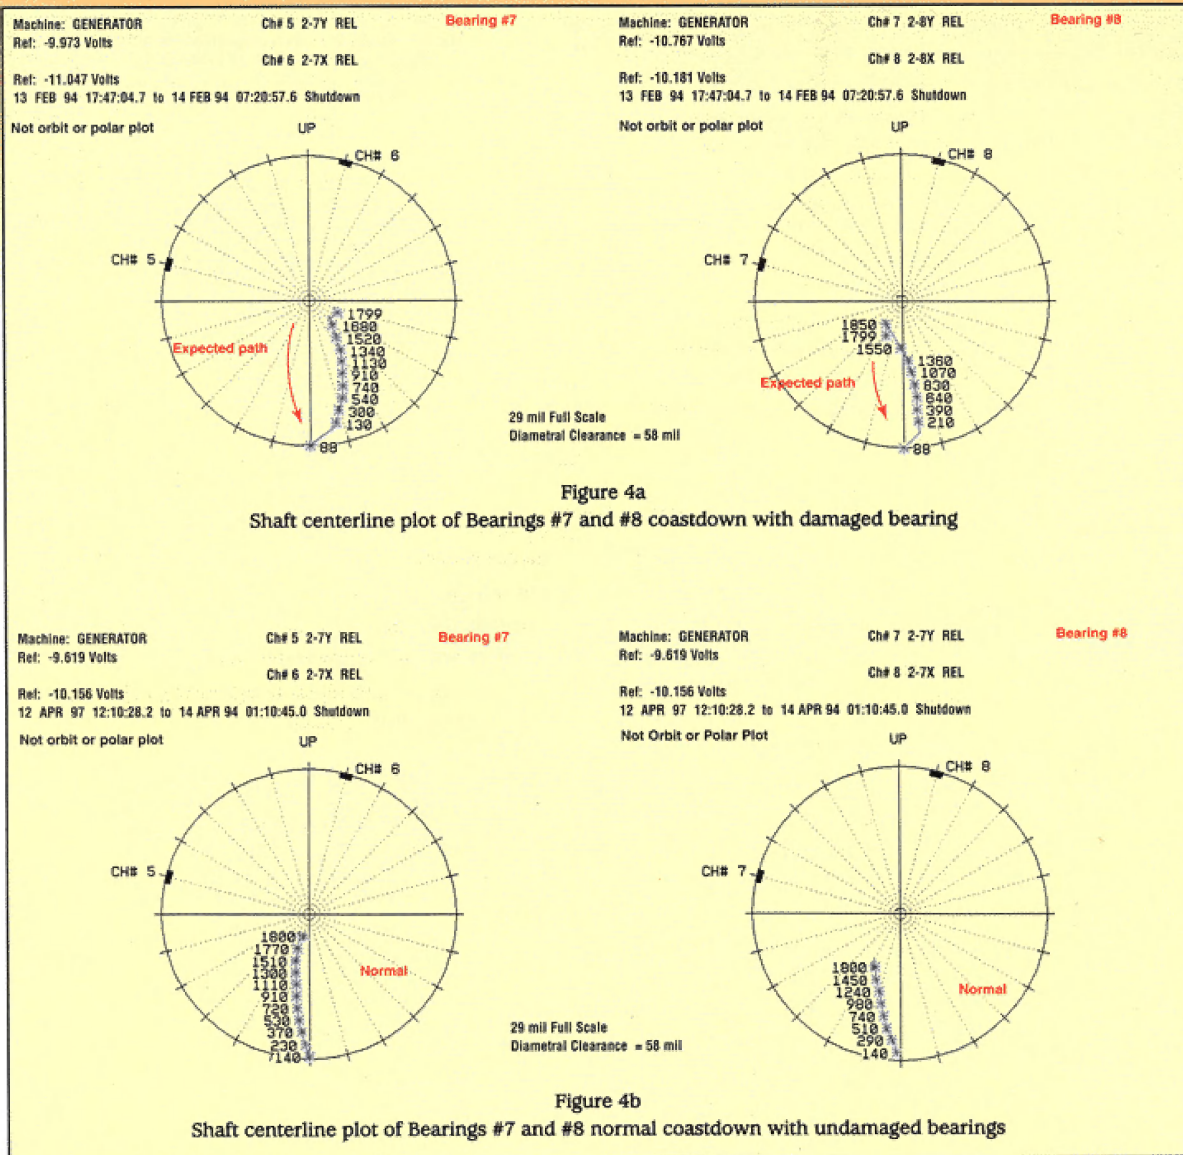
The shaft centerline coastdown path (Bearings #7 and #8) approached the turning gear position from the wrong quadrant. (Figure 4a). This pattern was not seen on previous coastdowns or startups (Figure 4b), and was a good indication that bearing damage had occurred. The damaged bearing surface modified the direction of the hydrodynamic forces in the bearing, which resulted in a different shaft position angle.

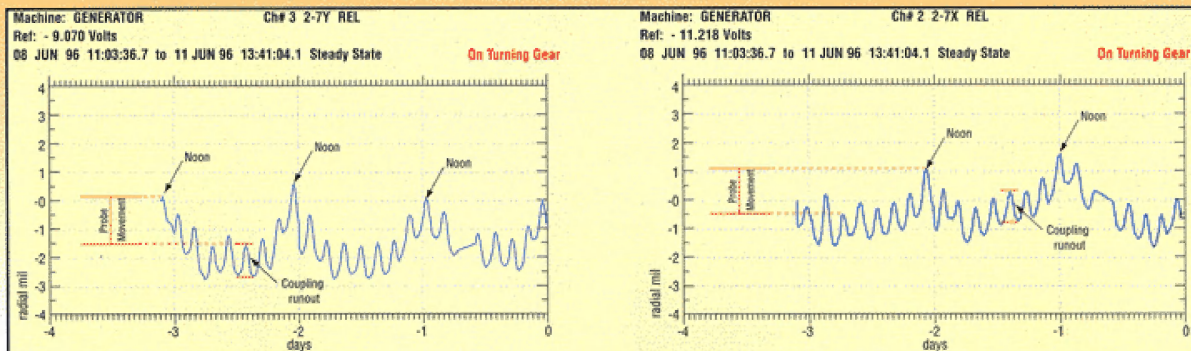
Figure 5a  
Normal flexure, on turning gear, of generator shell due to hydrogen cooler.

In contrast, trended gap voltage readings showed that the generator normally goes through a 1 to 2 mil flexure during a 24-hour cycle, both on turning gear and in normal operation, peaking at midnight and returning to normal at noon (Figure 5a and 5b).

The likely scenario that explains this data is that the hydrogen coolers, located on the top of the generator, cool the upper shell more than the lower shell. This should create an upward flexure that would lift the probes away from the shaft (as the generator bearings are internal, these probes are mounted to the generator shell). Later, the uneven temperature distribution would be alleviated by thermal heating from the sun and the apparent shaft position would return to normal.

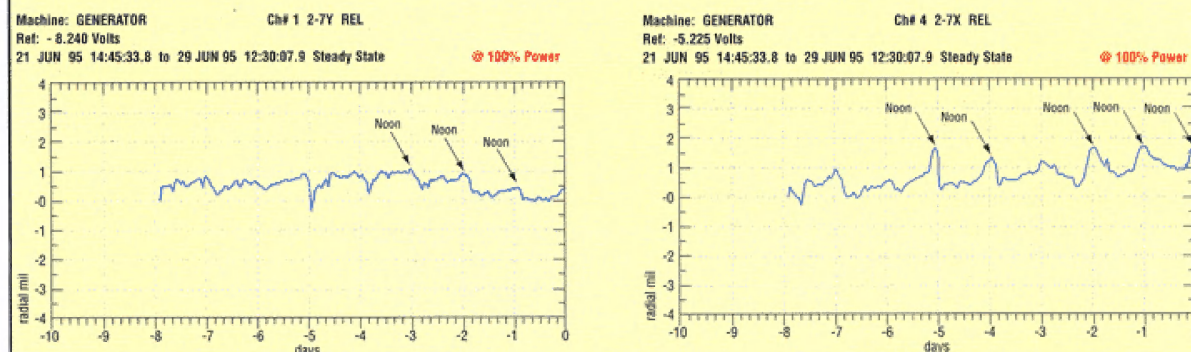
Figure 5b  
Normal flexure, at 100% power, of generator shell due to hydrogen cooler.

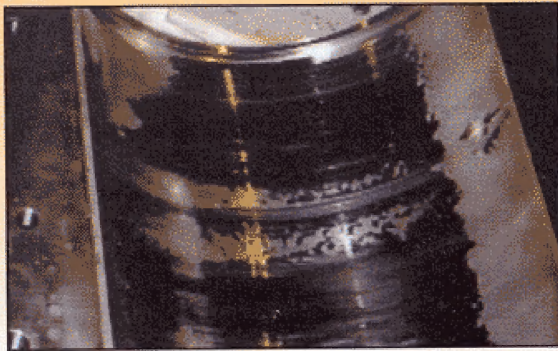
The available machinery data indicated a high probability of degradation at Bearings #7, #8 and #9, and the decision was made to perform a bearing inspection. Each bearing was found to be wiped. The increased clearances led to the changes in position documented in the steady state and transient vibration

information. In addition, Bearing #7 had ingested a small washer, which gouged a chunk out of the babbitt material, and then became imbedded (Photos 1 & 2).
